FRIENDS OF ST. ROSE, INC.

# Church of St. Rose of Lima

## Building Condition Assessment

2015 March

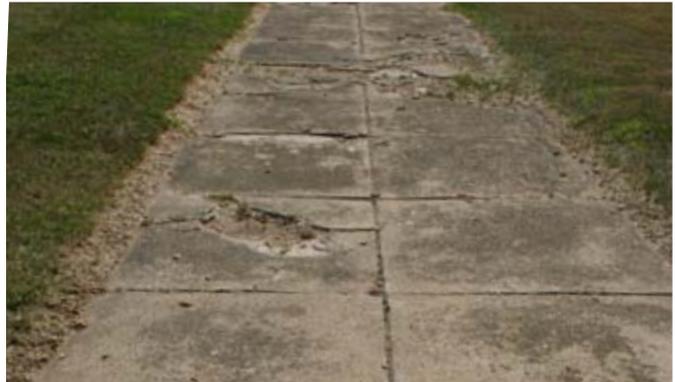
The condition of the sidewalks has deteriorated to the point that patching is no longer an option. Not only are sections of the concrete heaving, but deep cracks have telegraphed completely through the slabs. (See Figures 2, 3 & 4). Given the age and the condition of the concrete, repair is not possible. The location of the three walks, from the north, west and south gives ample access to the building. Unfortunately, none of the accesses are ADA compliant. Even if the walks were level and in good condition, the distance from the start of the paths to the entrance is excessive.

**Figure 2:** Deterioration at the south sidewalk is typical of the poor condition of the sidewalk system on the site.

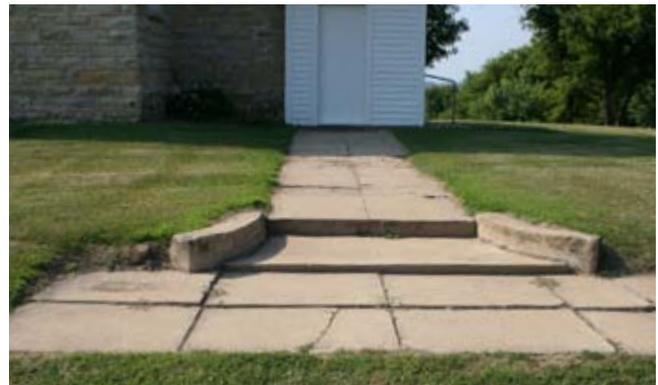
**Figure 3:** Heaving and crumbling concrete on the north sidewalk is a tripping hazard.

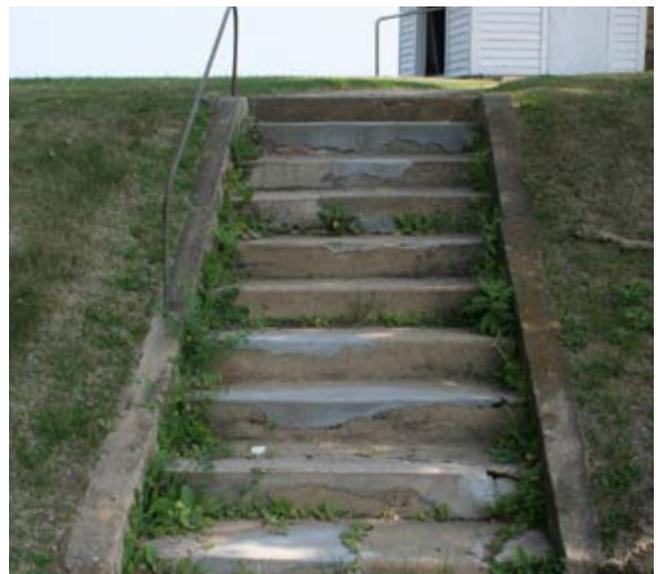
Stairs lead from the parking lot and the driveway up to the south and west sidewalks. Both sets of stairs are concrete and of an age similar to the sidewalks. Traversing the stairs is difficult at best. Over time the stairs have begun to pitch in varying directions. This has also caused the stairs risers to vary from a scant 6" to 8" plus. This problem is exacerbated at the south stair. In both cases the concrete has crumbed and then been patched multiple times. At the base of the stairs there are short 3' retaining walls that flank the stairs. The walls have begun to buckle and crumble, some of the problems caused by roots from nearby trees.

**Figure 4:** The south stair shows typical heaving stairs with both the original and patched concrete crumbling. Railing is not code compliant.

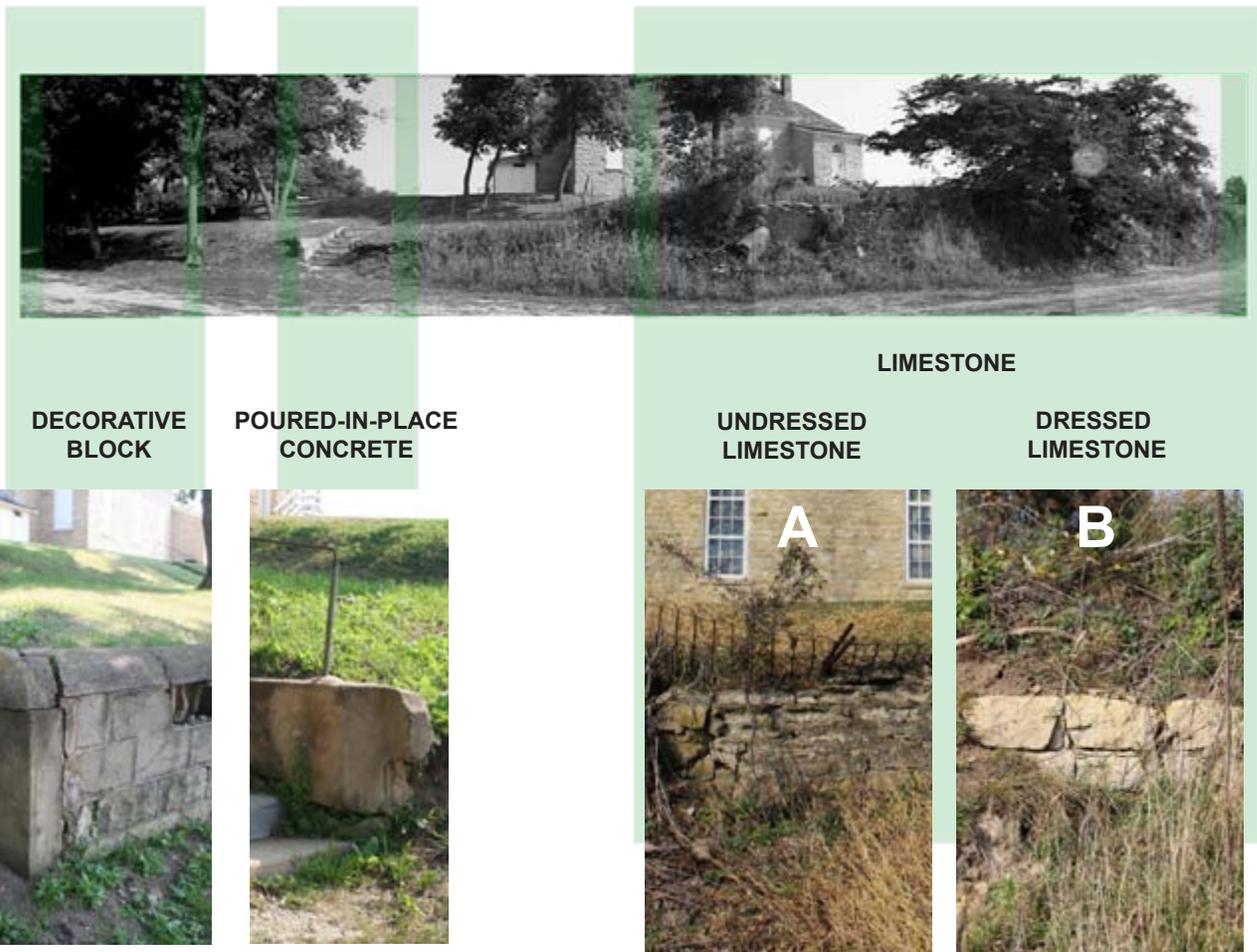
There is nothing remarkable about the poured-in-place concrete walls. The finish, although now pitted with age, was originally smooth with a small dark aggregate mix. These walls, located at the bottom of the stairs, are cracked, crumbling and heaving in and out from the staircase.

The third wall type is the decorative concrete block located at the southwest corner and intermittently along the west at the driveway. These walls have had the original decorative block infilled with plain CMU. The wall has a poured-in-place cap. Unfortunately, the decorative block walls have completely failed.

**Figure 5:** The south elevation shows the three types of retaining walls, the close-ups reveal their condition.

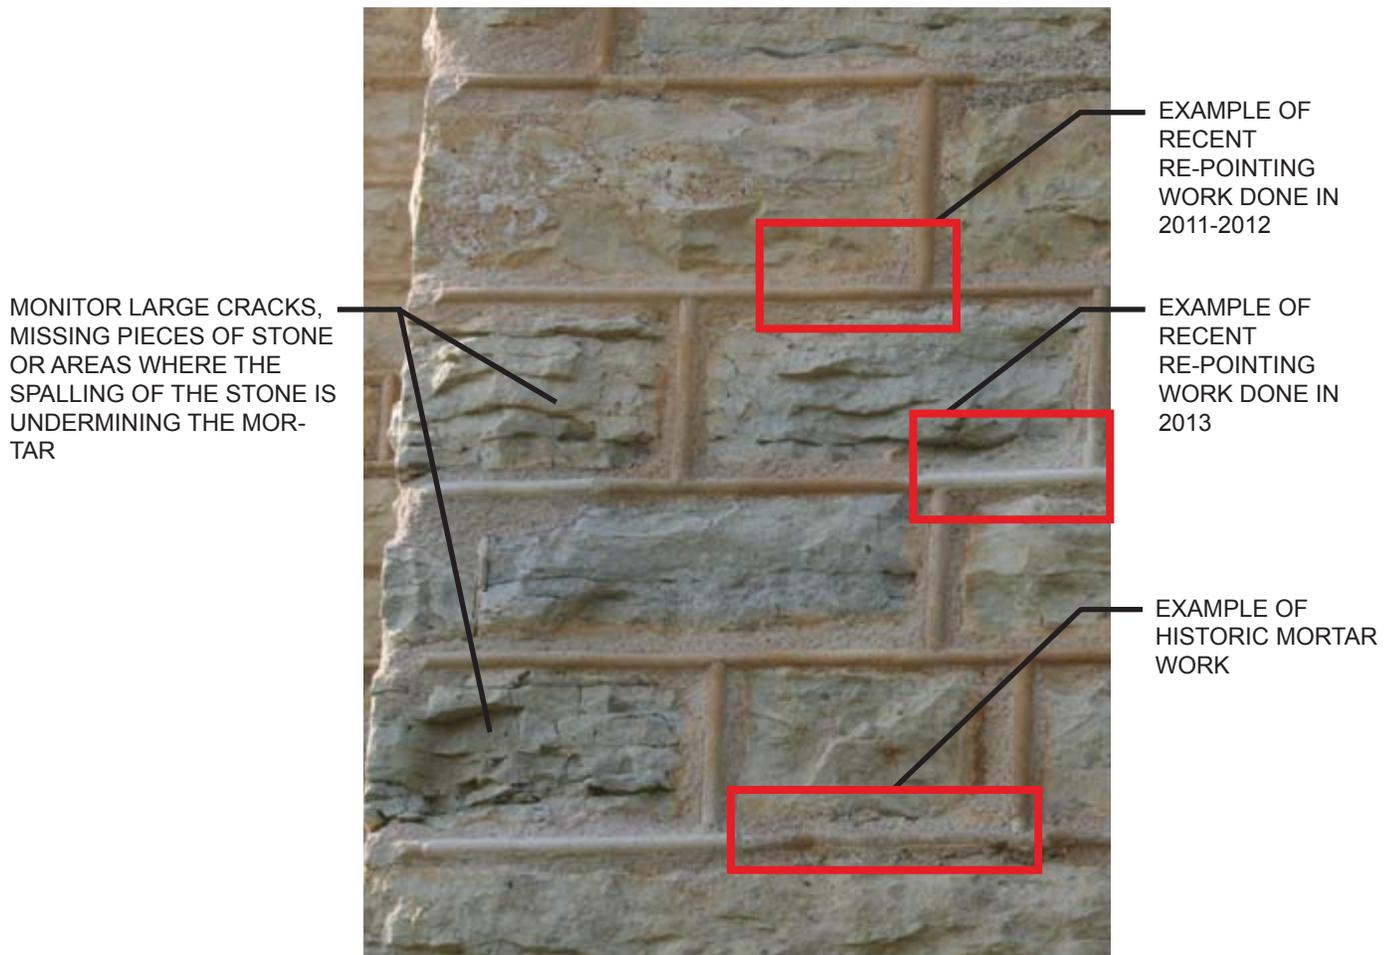
**Figure 14:** Examples of spalling stones and the new mortar next to the historic mortar on the north elevation.

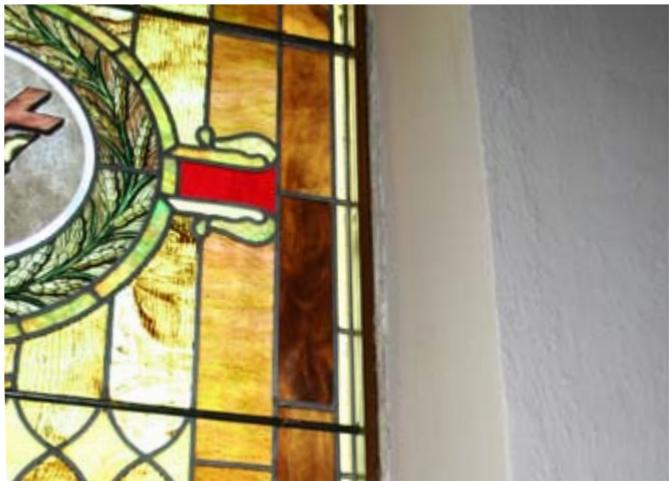
**Figure 16:** Interior view of the stained glass windows, caning in good condition

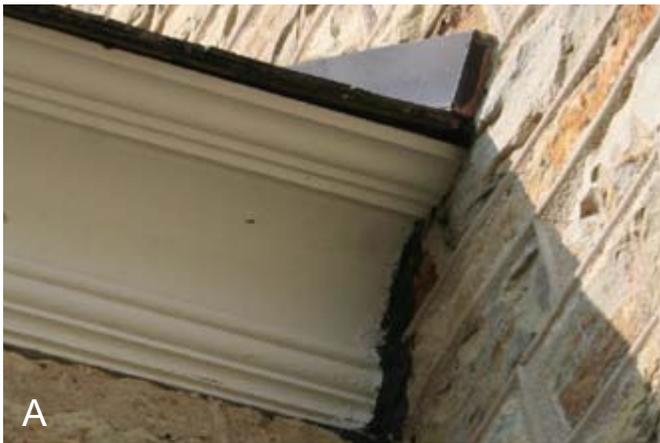
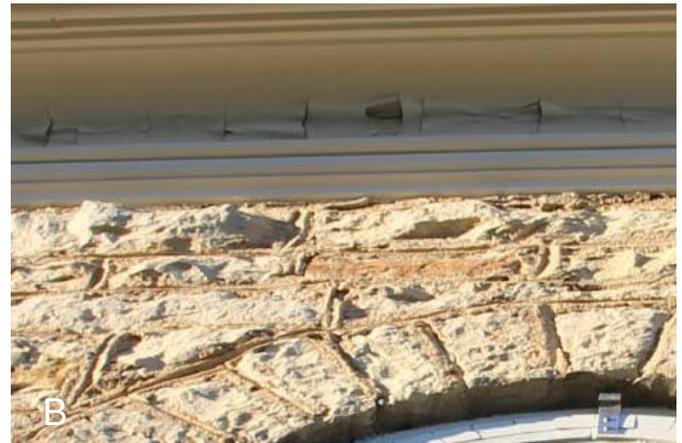
The connection between the double hipped roof and the main building are of some concern and in need of attention. At this location, the joint has opened up and an excessive amount of sealant has been applied to the area

**Figure 18:** A. Patching gaps this large with sealant, as shown here, will lead to leaking.

B. Failing paint at cornice.

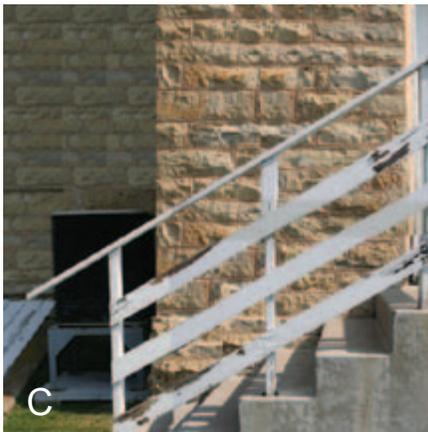
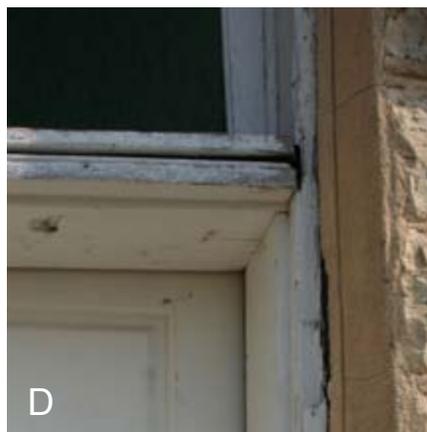
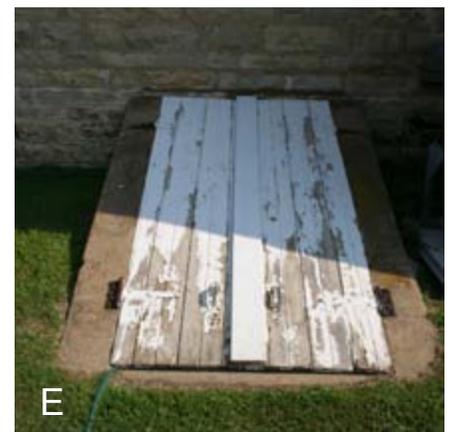
Just to the west of the sacristy door is a cellar (hurricane) door leading to the basement. The wood slat door and frame are mounted to poured-in place concrete kneewalls. Due to the condition of the door, it is neither weather tight or able to be secured.

**Figure 19:** C. Railing decay at sacristy stair. D. Door and frame decay at sacristy entry E. Cellar door decay

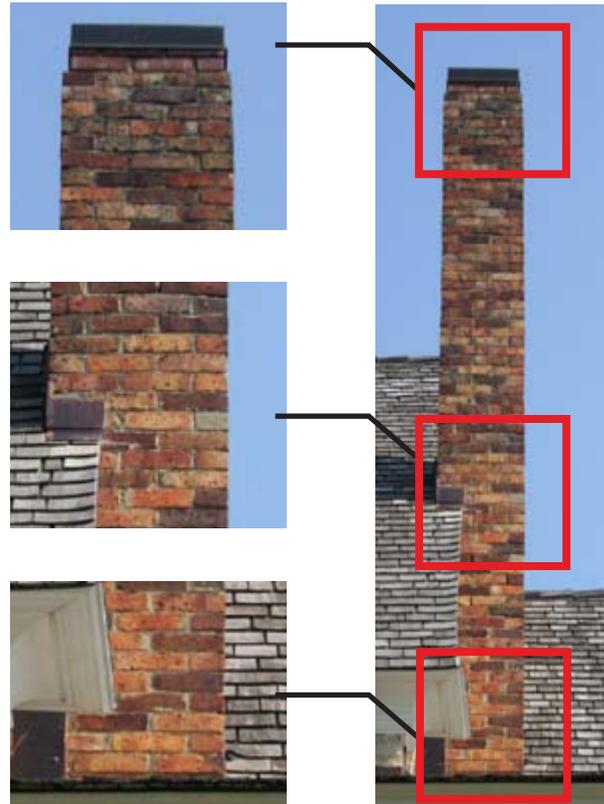
**Figure 20:** Furnace chimney showing loose and missing mortar, brick deterioration. Copper flashing was installed in 2005, and the copper cap installed in 2009.

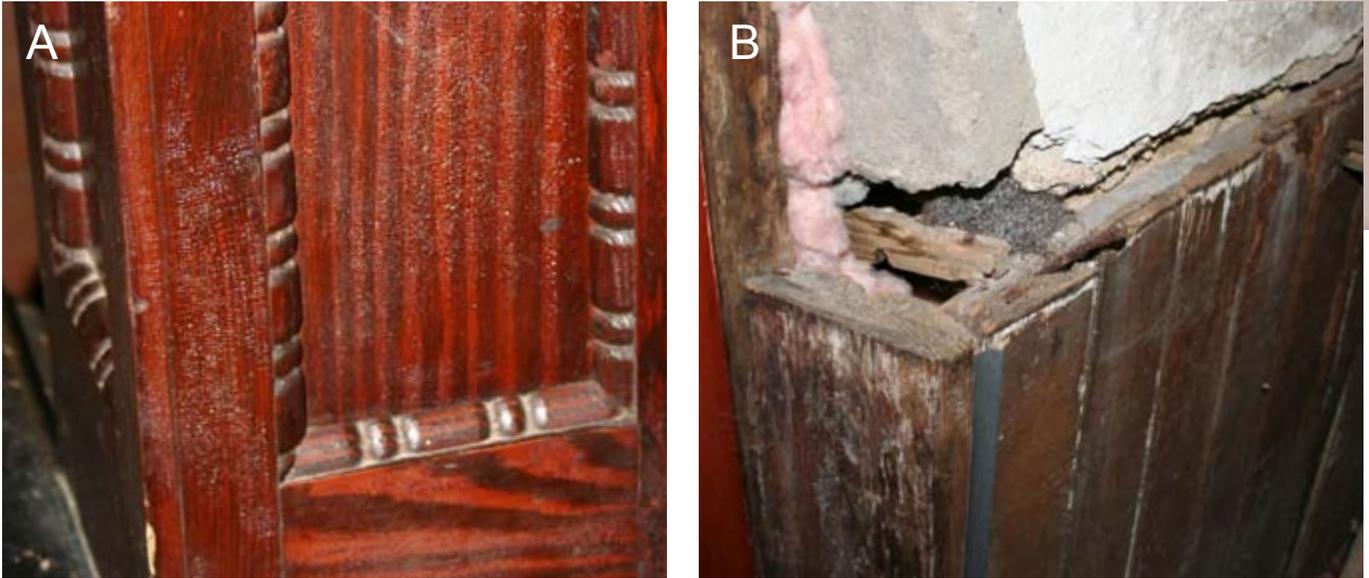
**Figure 30:** Woodwork A. Typical crazing on woodwork B. Damage to wainscoting in sacristy, rot and pest damage.

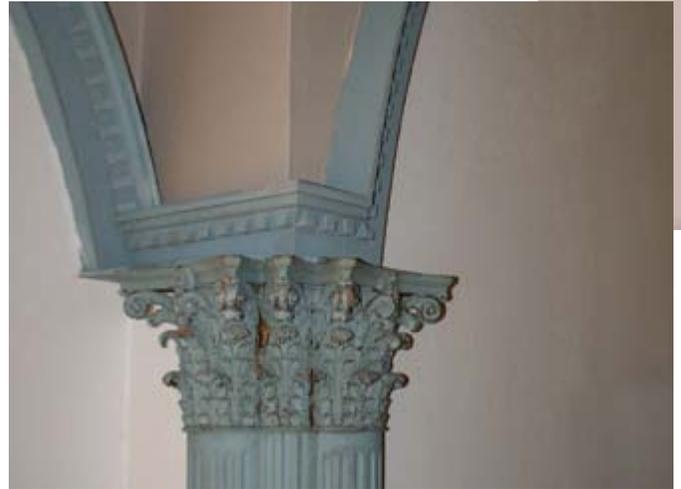
The moldings and pilasters are in good condition, with the exception of peeling paint and dirt build-up. No rot or pest damage was noted. At the capitals on the pilasters the paint is flaking off leaving the gild exposed below.

**Figure 33:** Capital and moldings at top of pilasters

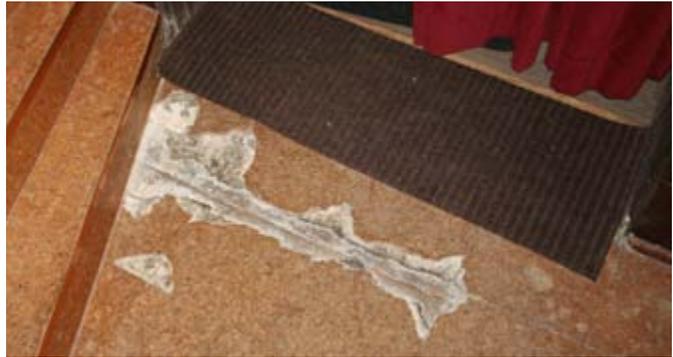
**Figure 37:** Damaged floor covering over wood floors at sanctuary, typical this area.

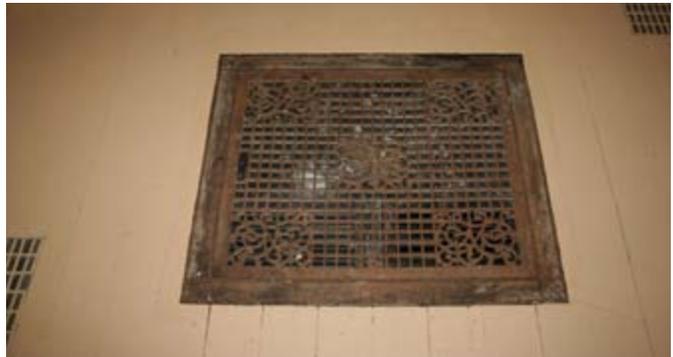
Another tripping hazard exists just outside the chancel in the front of the nave. (See Figure 38). Here a large historic heating grate is set in the floor. The openings in the grate may allow shoe heels to slip through the grate and become stuck. Although this is the most prominent grate, there is another one under the first row of pews.

**Figure 38:** Open metal grate for air return at nave is a tripping hazard at edges and high heel hazard in open areas.

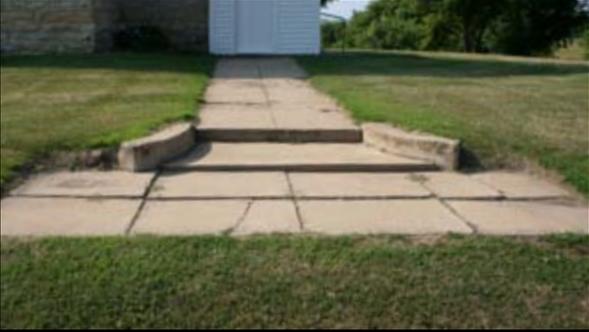
<p>Stairs: From parking and driveway</p>	<ol style="list-style-type: none"> <li>1. Stairs from the parking lot and driveway are heaving, cracking and spalling. They have deteriorated beyond repair.</li> <li>2. Stairs are not code compliant. They do not provide an even walking surface. There is not a consistent rise on the steps.</li> </ol>

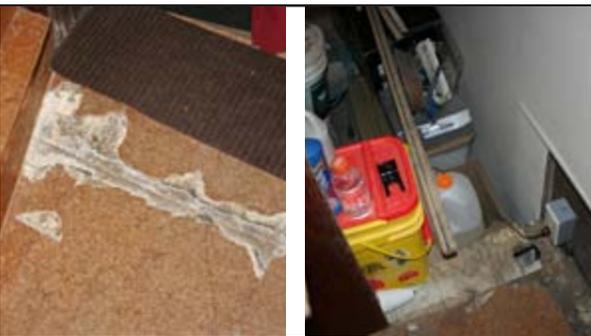
<p>Floor at Nave</p>	<ol style="list-style-type: none"> <li>1. Furnace grates may be a tripping hazard.</li> <li>2. Furnace grates have begun to rust.</li> </ol>
