FRIENDS OF ST. ROSE, INC.

# Church of St. Rose of Lima

## Building Condition Assessment

2015 March

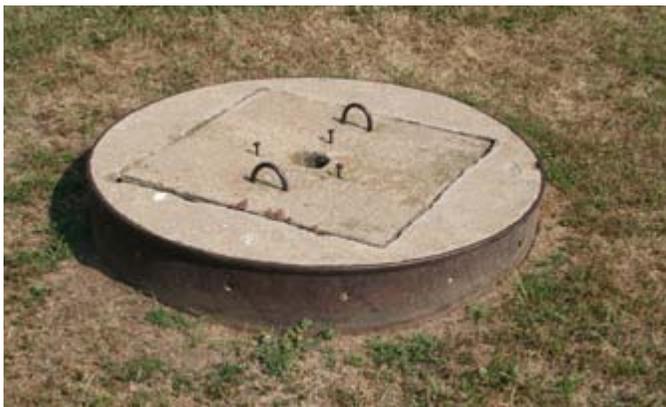
There is an abandoned cistern on the site, just to the south of the sacristy. For safety, the cistern has been filled with sand so as to render it harmless. (See Figure 6).

**Figure 6:** Abandoned cistern filled with sand.

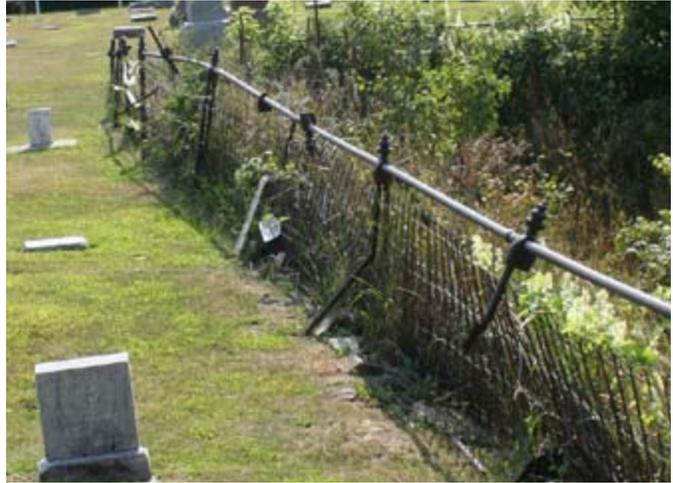
Running along the south side of the cemetery property, there is a 38" twisted wire fence that runs west to east just inside the top of the stacked stone retaining wall. Although the fence belongs to the cemetery, it is a visual and historic link between the two properties. (See Figures 7 & 8). This fence does not meet code, and considering that it is the barrier between the cemetery property on the upper level and the church property parking lot, it is a safety concern. The fence is yet another chance to further enhance the properties historic value.

**Figure 7:** Metal fence between upper level at cemetery and lower level parking lot.

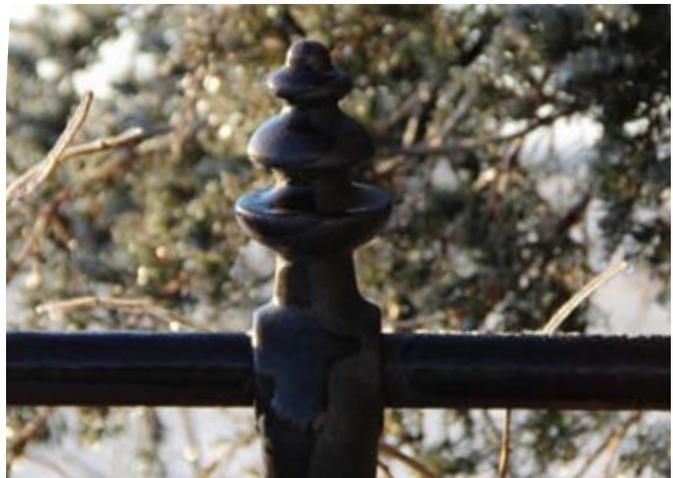
**Figure 8:** Close up of railing finial.

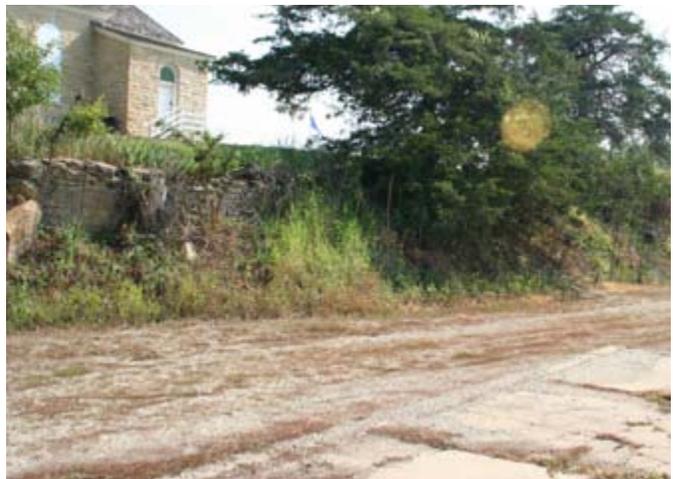
Neither the driveway nor the parking lot are paved, although there is a concrete slab in the parking lot. The slab took the plan of the original horse and buggy barn that once stood in this area. (See Figure 9).

**Figure 9:** Crushed rock parking lot, typical of the drive through the site. Concrete slab from where a horse barn once stood is in the lower right.

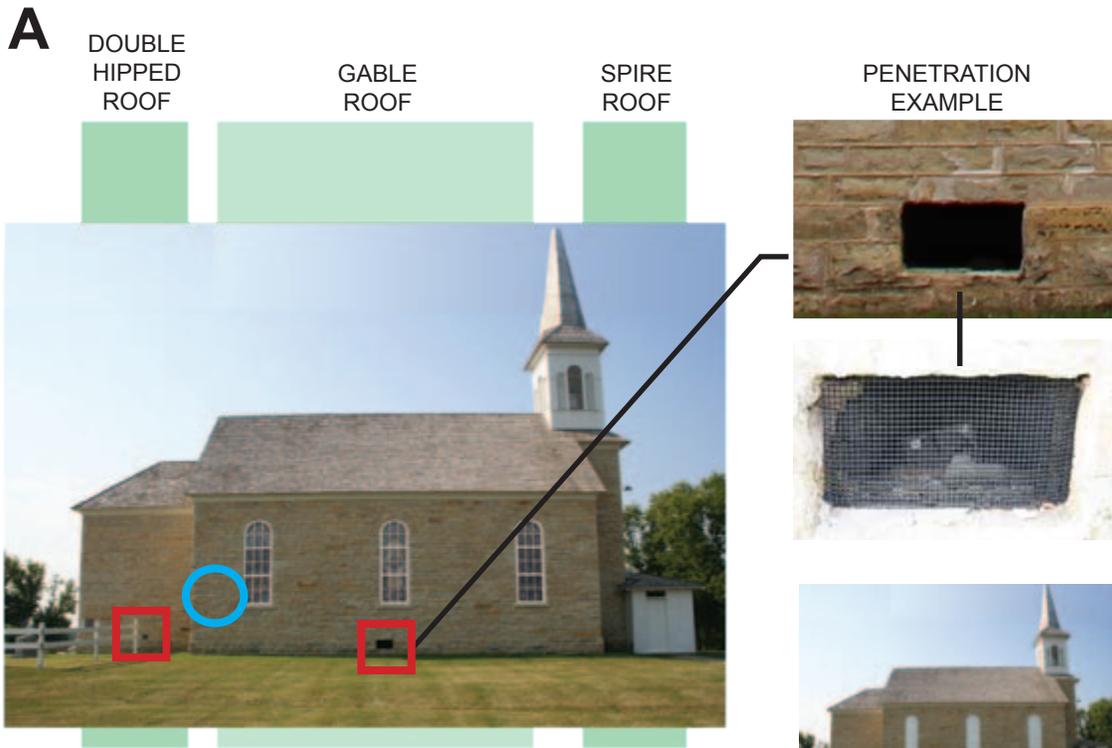
**Figure 12:** North elevation.

**Figure 12A:** North elevation showing window protection.

There are a few penetrations in the stone that are open to the elements, some having been filled with wood or mesh. (See Figures 12, 13 & 14). These areas are of concern because the penetrations give water and pests access points into the building.

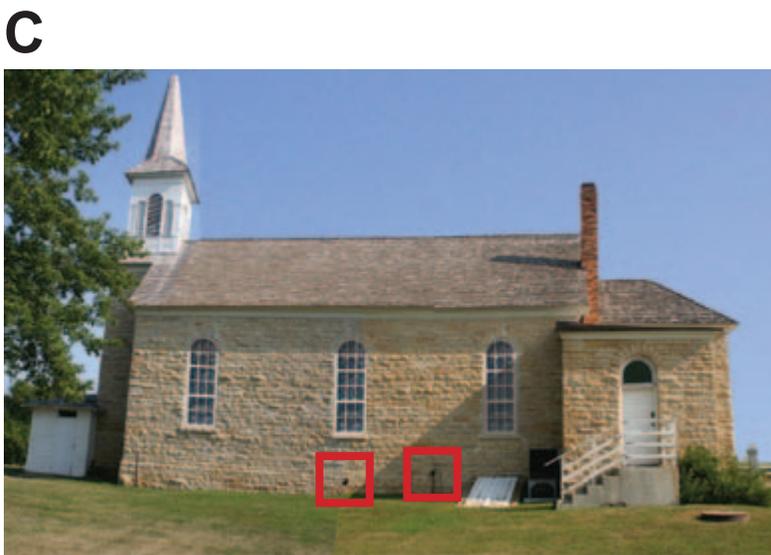
**Figure 13:** South elevation showing entrance into the sacristy and access to basement / crawl space.

**Figure 13A:** South elevation showing window protection.

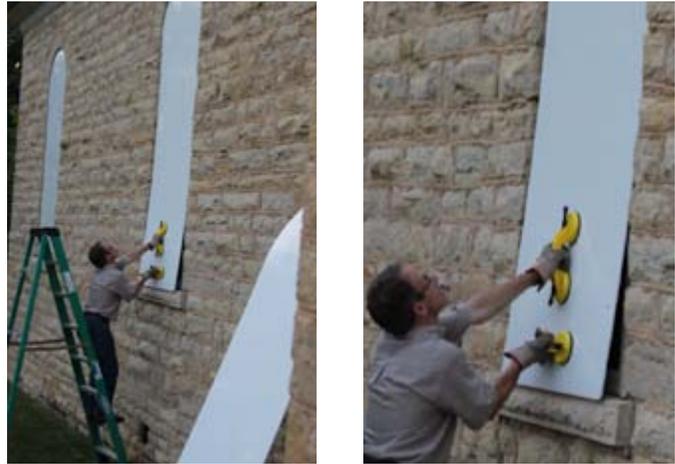
Full Alumicore (corrugated aluminum) covers protect eight of the stained glass windows. The covers, which are removable, are screwed in at the bottom and slip into clips at the top, for ease of removal. There are two concerns with the covers. First, over time, removing and re-attaching the covers may cause damage to the window frame. Second, the gap between the cover and the stone may promote water infiltration. At this time, no damage has taken place. (See Figure 15). The windows should be monitored for proper drainage and any infestation.

**Figure 15:** Typical window cover has screws at the bottom and slip clips at the top allowing the cover to be removed easily

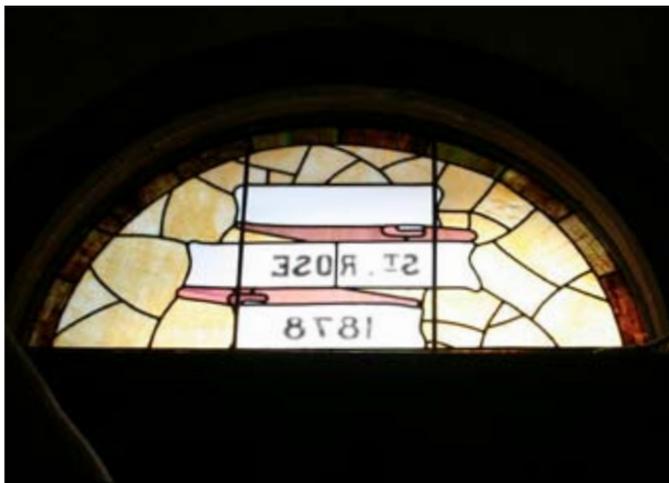
Over the main entry door is a half-moon stained glass window. This window is protected by its original divided glass storm window. (See Figure 17). The concern with this window is how the wooden vestibule ties into the building at the base of the window frame. There is high likelihood of wood rot and building envelope compromise if the joint between the vestibule, building, and window is not maintained properly.

**Figure 17:** Half-moon stained glass window visible from the interior.

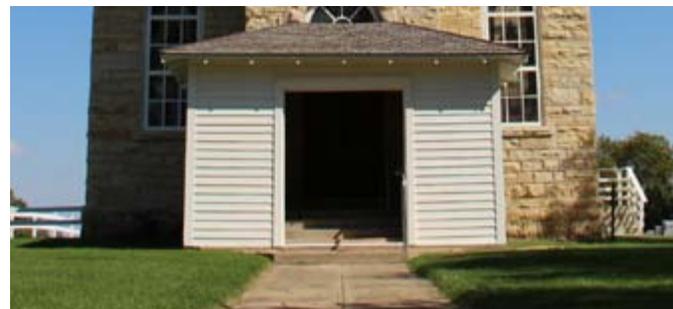
In 1913 a wooden vestibule was added to the west end of the 1878 building at the main entrance. (See Figure 21). The construction is typical residential wood stud with wood lap siding on the exterior and exposed framing on the interior. Concrete stairs start at the edge of the vestibule and rise as you pass through it. There are three doors leading into the space, from the north, south and west.

Given that the vestibule is not original and that it rests on the exterior stairs, there is probably no structural footing supporting it. That being said, the structure remains relatively true. The roof line does show signs of sagging, which could become an issue where the vestibule and the building meet.

The concrete steps are in a similar condition to the sidewalks. There is heaving, and large cracks, throughout the stairs. A temporary railing has been mounted to the

**Figure 21:** Wooden vestibule constructed to help protect the historic entry and keep the steps clear.

stairs to help mitigate the safety issues. This entry is neither code nor ADA compliant.

Although the vestibule does serve an important function, that of mitigating air infiltration, its attachment to the building may be causing damage to both the limestone building and the half moon window. ADA and code compliant options should be explored.

Given that the vestibule is not original to the church, that its connection to the masonry may be causing damage, and that its condition requires extensive refurbishing, it is recommended that the vestibule be removed. The removal will, in coordination with restoration of the front doors, solve the masonry deterioration issue as well as allowing for future ramp work.

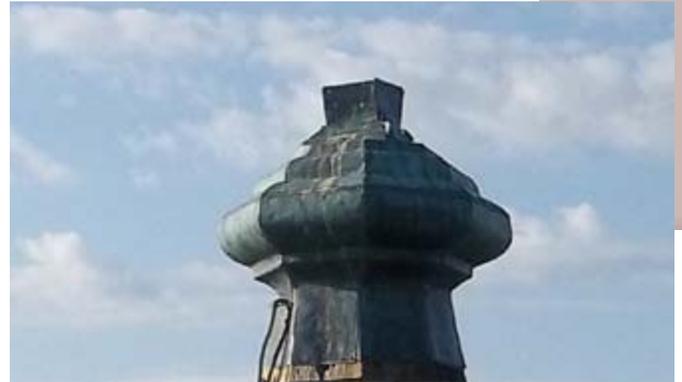
**Figure 22:** Copper finial on the spire before it was removed to be restored.

Although the copper cross and finial are no longer on the spire, the church is in possession of the finial. (See Figure 22). The finial should be restored and put back in place. Since the cross is no longer on site, a new one should be fabricated using available photos and information. When the finial was removed for restoration of the spire roof, photos were taken of the structure that once supported the finial and the cross. (See Figure 23).

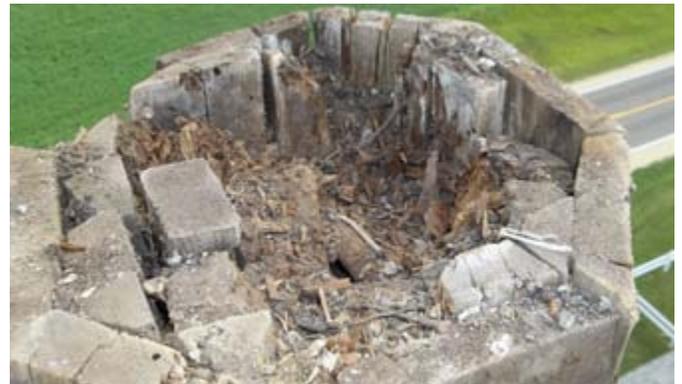
**Figure 23:** After the finial was removed, looking into the structure that remains.

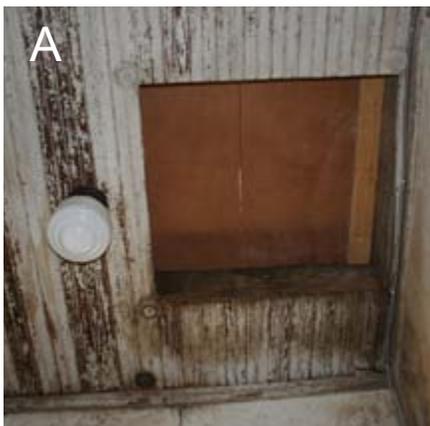
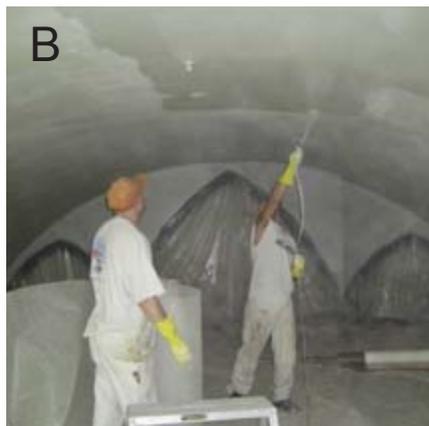
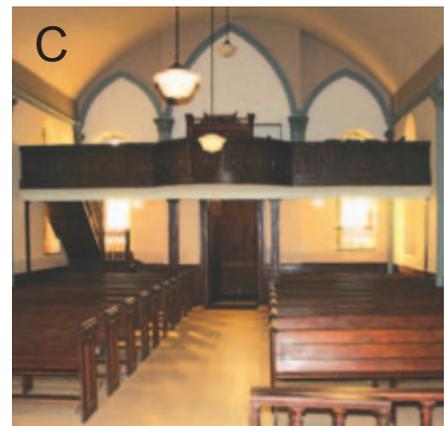
Unlike the rest of the building, the narthex has a bead board ceiling. Access to the belfry is through a trap door in this ceiling. Both the existing trap door and the ceiling show signs of damage from water and years of having the building unoccupied. Further investigation needs to occur to determine whether the ceiling can be refurbished. Future work includes the restoration of the top of the spire, which will necessitate work in this area.

As part of the on-going restoration work, the plaster barrel vault ceiling in the rest of the church has been restored. In order to help stabilize the ceiling, a fiber mesh underlayment was used. Over the last year a crack has developed over the length of the vault. The most likely cause of this crack is the fact that the building went unheated for several weeks last winter. The plaster is not capable of maintaining its structural stability when subjected to extreme temperature swings.

**Figure 29: Ceiling Types** A. Bead board ceiling in the narthex B. Plaster barrel vault ceiling being refurbished C. Refurbished plaster barrel vault.

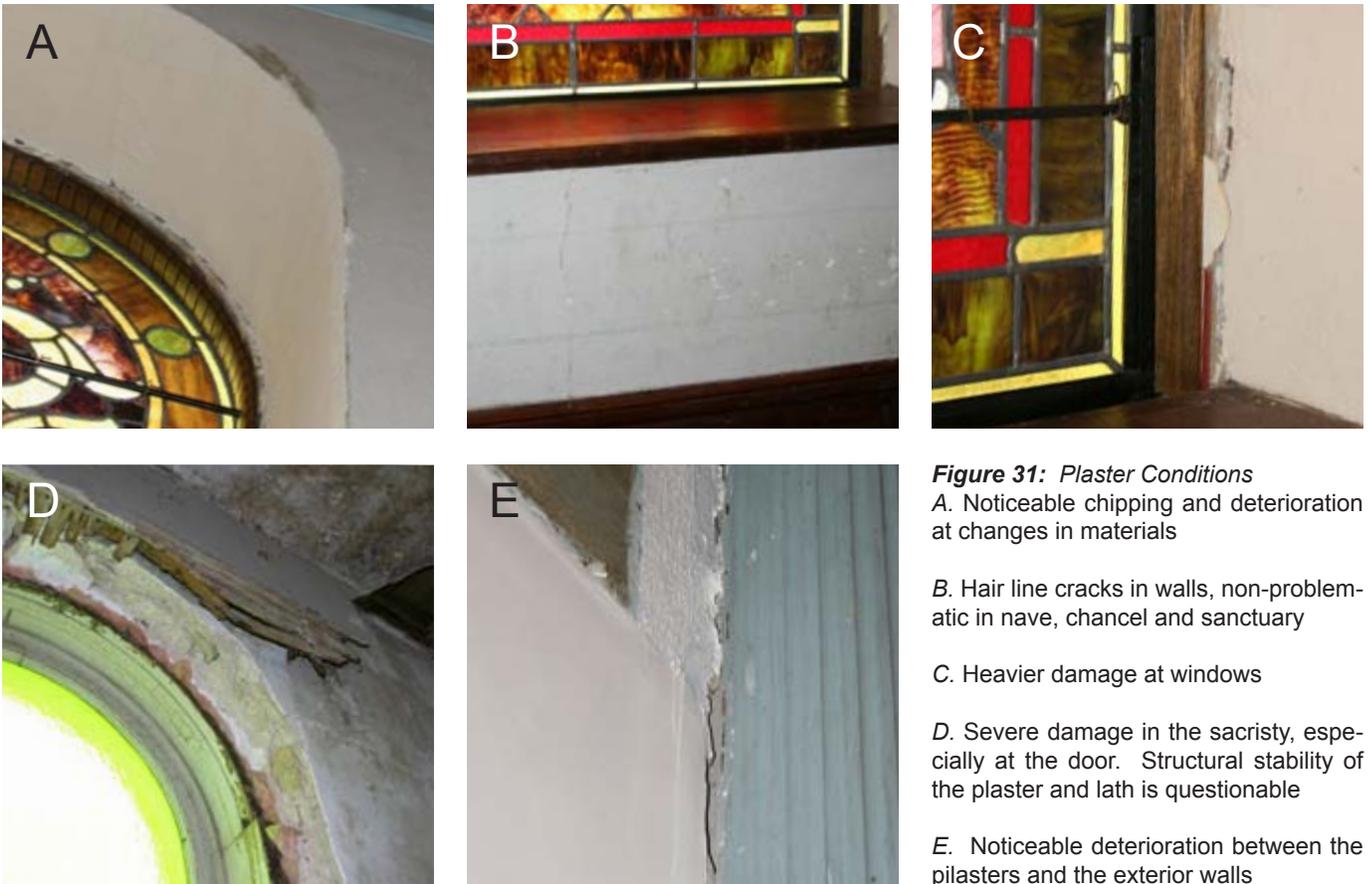
**Figure 31: Plaster Conditions**

A. Noticeable chipping and deterioration at changes in materials

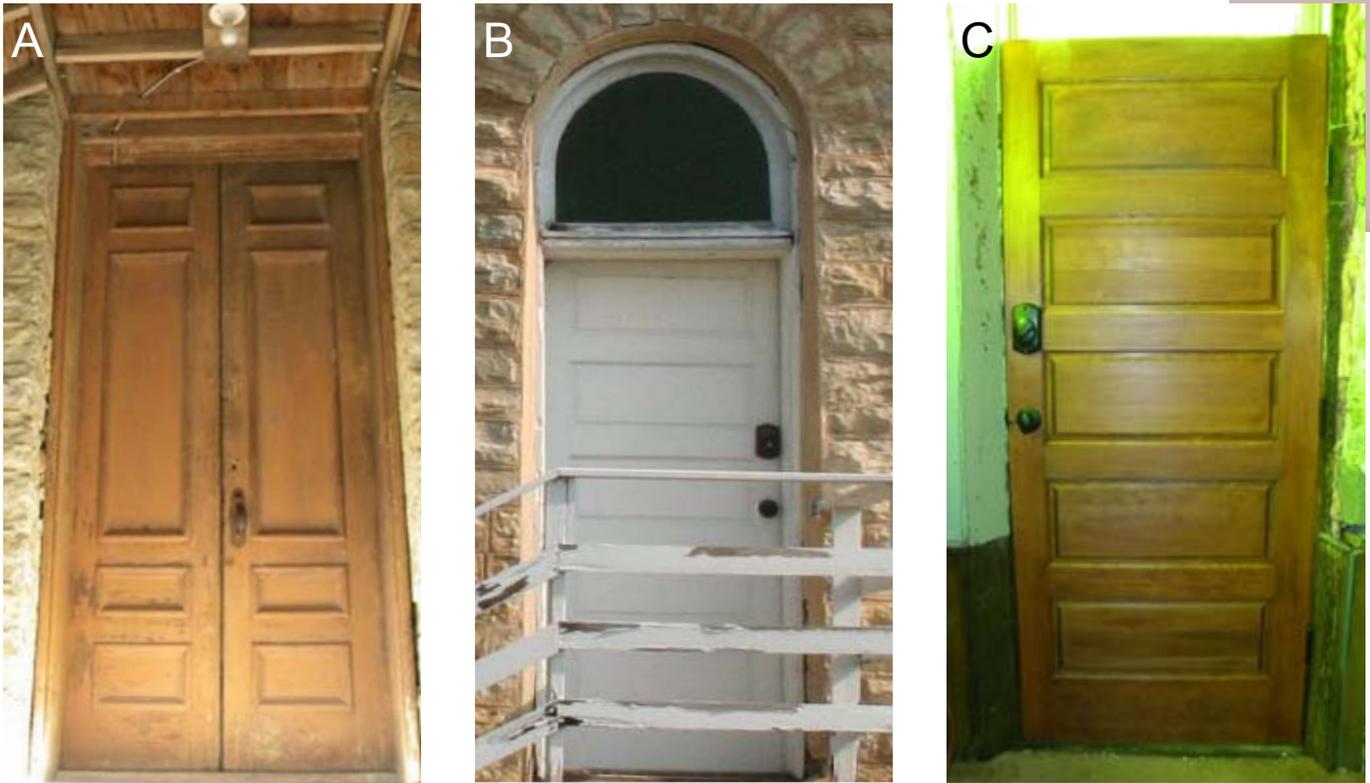
On the south elevation there is an exterior fir door leading into the sacristy. This door, which was replaced in 2012, and the clerestory glass above are not historic, but the frame around both is original. Both the door and the window frames have decay and pest damage. It is unlikely that this door offers any weather protection for the building.

**Figure 39:** Exterior doors - **A** Main entry at narthex **B** Entry at sacristy **C** Interior side of sacristy door

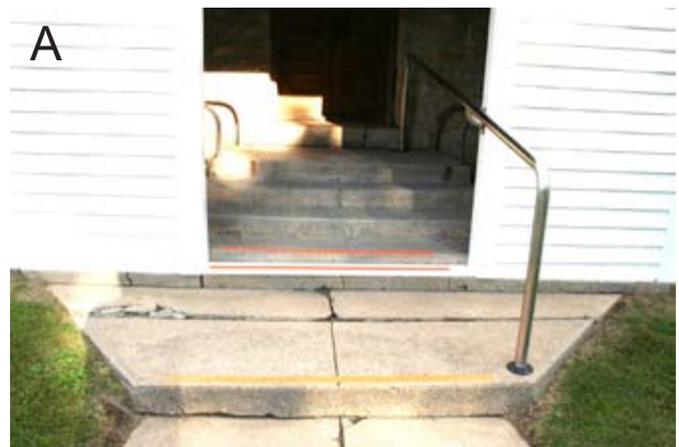
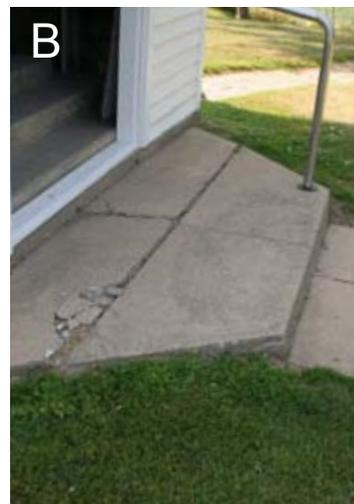
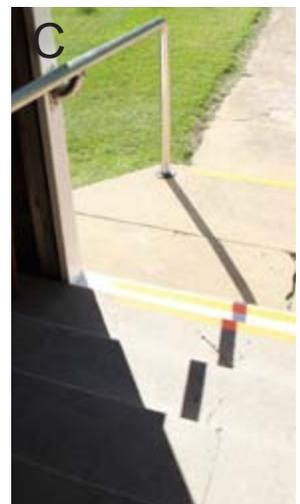
As the vestibule exists currently, it would not be possible to tie ramps into the building at the front door. There is not enough head room to raise the exterior steps so that they are at the same elevation as the interior of the building, nor is there enough space to accommodate the required turning radius to be ADA compliant.

**Figure 44:** Stairs and vestibule do not allow for visitors with accessibility issues to enter the building: A Looking east, B Looking south, C Looking west.

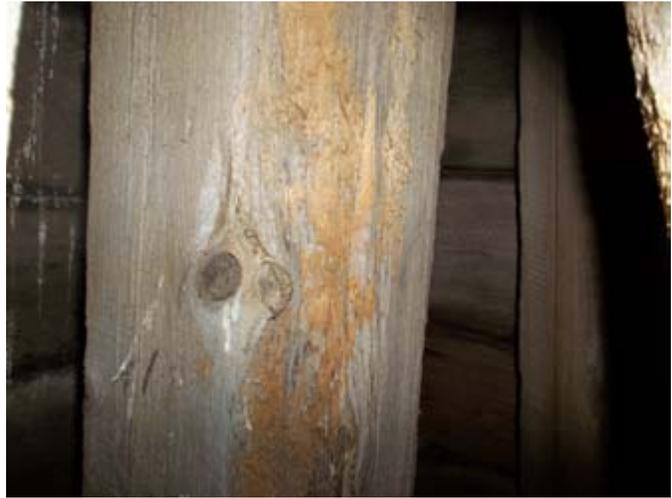
**Figure 45:** Existing interior of the spire where the attachment of the new wood will occur.

For this work a Structural Engineer should be employed to evaluate the existing wood, and comment on the proposed attachments. A dutch lap splice is recommended, with appropriate re-enforcing. The steel should run past the splice in each direction to further secure the splice.

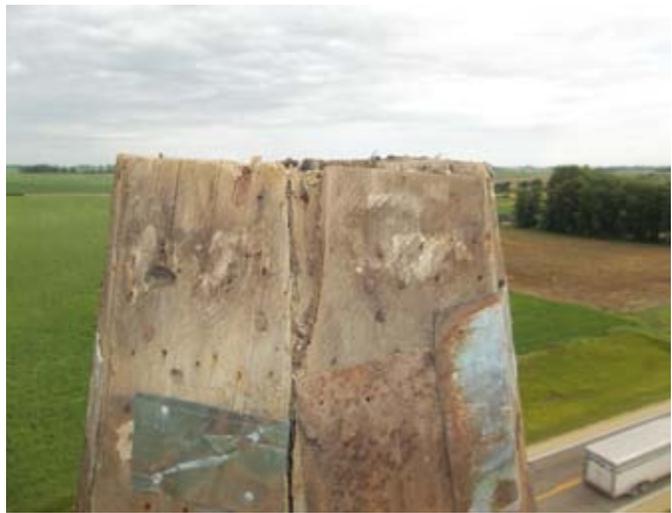
**Figure 46:** Existing top of spire.

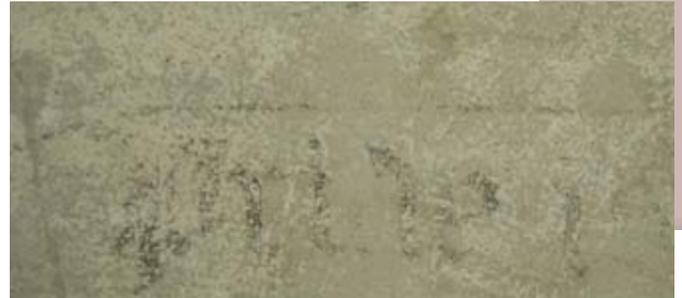
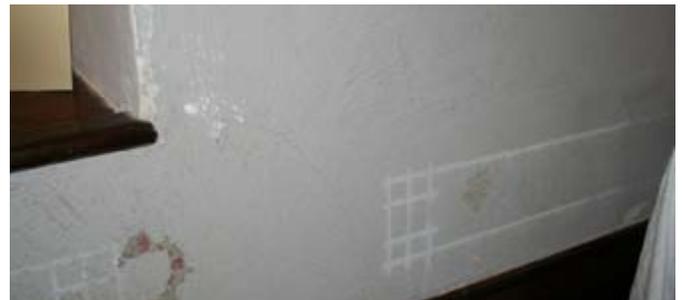
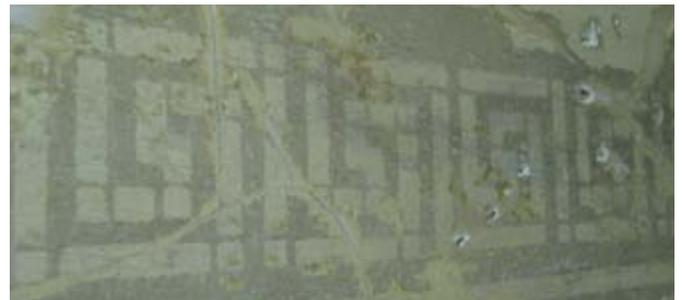
**Figure 48:** Remnants of original frescoes and decorative work.

During the restoration of the plaster consideration should be given to the frescoes. Historic documentation, both written and photographic, indicates extensive decorative work through-out the church.

Whenever possible existing samples of the frescoes should be retained as they are a wealth of information about color and technique. This information will be a guide to both the pigments, but also the unique strokes used to form the work.

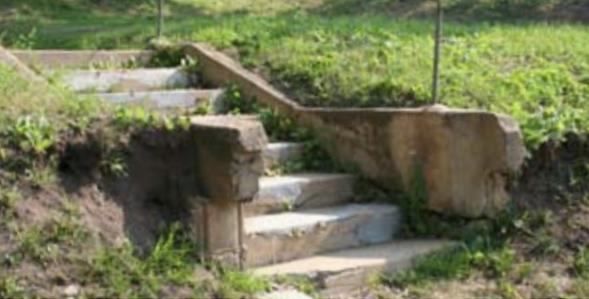
<p>Retaining Walls: Concrete</p>	<ol style="list-style-type: none"> <li>1. Poured-in-place concrete walls are heaving, cracking, and spalling. They have deteriorated beyond repair.</li> <li>2. The walls that were once retaining soil have now completely disintegrated.</li> </ol>

Recommended Repairs	Level of Importance	Estimated Cost
<ul style="list-style-type: none"> <li>• Repair or replace sidewalks that are not able to be repaired.</li> <li>• Sidewalks and access to the sidewalks are to be ADA compliant.</li> </ul>	MODERATE	\$ 45,000.00
<ul style="list-style-type: none"> <li>• Repair or replace stairs that are not able to be repaired.</li> <li>• Stairs should be code compliant with even walking surfaces and consistent rises and runs.</li> <li>• Provide ADA compliant railings for all stairs.</li> </ul>	HIGH	\$ 9,000.00
<ul style="list-style-type: none"> <li>• Limestone retaining walls are to be repaired with matching limestone if possible, or replaced with historically accurate limestone.</li> <li>• Walls are to be made structurally stable.</li> </ul>	LOW	\$ 15,000.00
<ul style="list-style-type: none"> <li>• Decayed concrete retaining walls are to be replaced with historically accurate limestone walls.</li> <li>• Walls are to be structurally stable.</li> </ul>	LOW	\$ 70,000.00

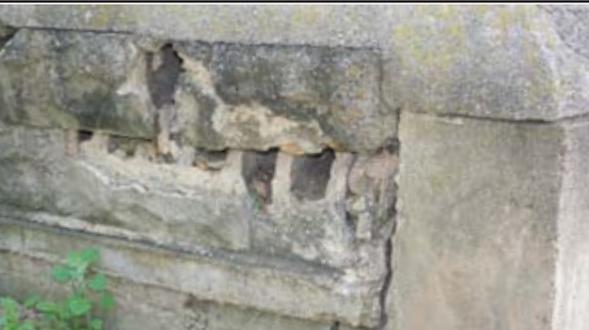
<p>Retaining Walls: Decorative Block</p>	<ol style="list-style-type: none"> <li>1. The decorative block is disintegrating, leaving most of the cells open to ice and water infiltration. Many of the original blocks have been replaced with CMU, which is also beginning to deteriorate.</li> <li>2. These walls have a poured-in-place concrete top. The concrete is heaving and cracking, making it unable to be repaired.</li> </ol>

<ul style="list-style-type: none"> <li>• Missing decorative blocks are to be replaced with new, historically accurate decorative blocks.</li> <li>• Retaining walls are to be replaced with historically accurate limestone walls.</li> <li>• Walls are to be structurally stable.</li> </ul>	LOW	\$ 20,000.00

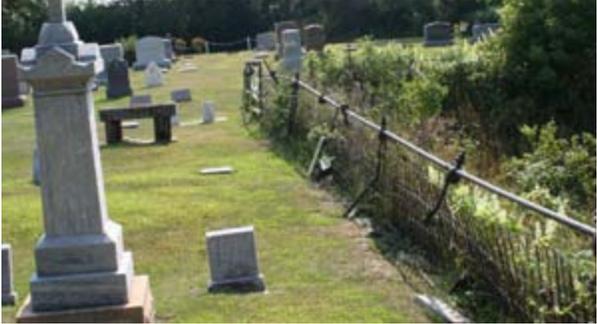
Item	Concern	Photo
Fencing	<ol style="list-style-type: none"><li>1. Fence does not meet code at parking lot.</li><li>2. Much of the fence has been replaced but many pieces are still missing.</li><li>3. Fence on church property is part of larger fence.</li></ol>

Recommended Repairs	Level of Importance	Estimated Cost
<p><b><i>This fence abuts the church property, but belongs to the cemetery</i></b></p> <ul style="list-style-type: none"> <li>• Work with the Cemetery Owner to replace fence with a code compliant alternative that is similar to the historic fence.</li> </ul>	<p>HIGH</p>	<p>\$ 57,000.00 By Others</p>
<ul style="list-style-type: none"> <li>• Pave the driveway and lot to better provide accessibility and erosion control, while also being cognizant of the historic fabric of the site.</li> </ul>	<p>LOW</p>	<p>\$ 33,500.00</p>

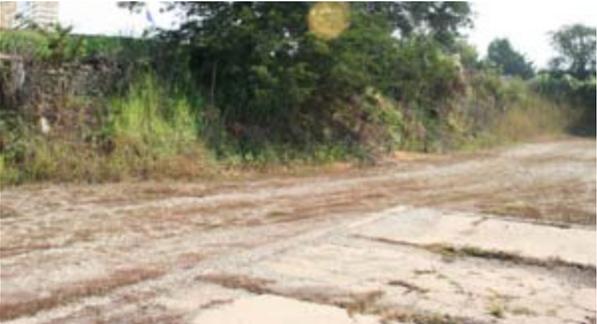
Driveway and Parking Lot	<ol style="list-style-type: none"><li>1. Both the driveway and the parking lot are unpaved, with the exception of a concrete slab that is a remnant of the horse barn slab.</li></ol>

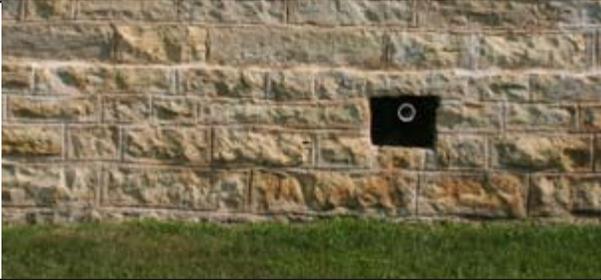
Item	Concern	Photo
Limestone Walls	<ol style="list-style-type: none"> <li>1. There are a few scattered penetrations that give water and pests access to the building.</li> <li>2. Deterioration of the stone has occurred and should be monitored for future replacement.</li> </ol>

Recommended Repairs	Level of Importance	Estimated Cost
<ul style="list-style-type: none"> <li>Patch and repair penetrations.</li> <li>Repair deterioration.</li> <li>Monitor for future replacement. (On-going Maintenance)</li> </ul>	<p style="text-align: center;">CRITICAL (Penetrations)</p> <p style="text-align: center;">LOW (On-Going)</p>	<p style="text-align: center;">\$ 5,500.00</p>
<ul style="list-style-type: none"> <li>Monitor for wood rot at window trim, every 6 months. (On-going Maintenance)</li> <li>Monitor for water infiltration, every 6 months. (On-going Maintenance)</li> </ul>	<p style="text-align: center;">LOW</p>	<p style="text-align: center;">TBD</p>
<ul style="list-style-type: none"> <li>Assess condition of window frames if/when covers are removed. (On-going Maintenance)</li> </ul>	<p style="text-align: center;">LOW</p>	<p style="text-align: center;">TBD</p>
<ul style="list-style-type: none"> <li>If vestibule is retained, seal and maintain the joint between the vestibule, building, and window.</li> </ul> <p>Monitor for wood decay and building envelope failure in the future. (On-going Maintenance)</p>	<p style="text-align: center;">LOW</p>	<p style="text-align: center;">\$ 750.00</p>

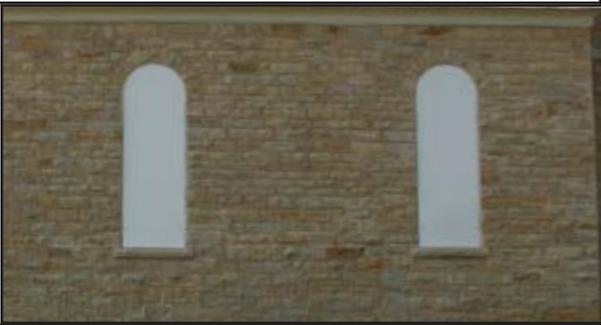
Window Covers	<ol style="list-style-type: none"> <li>1. Covers are removable. Removing and reattaching them may damage frame and window.</li> <li>2. Gaps between the covers and stone may promote water infiltration.</li> </ol>

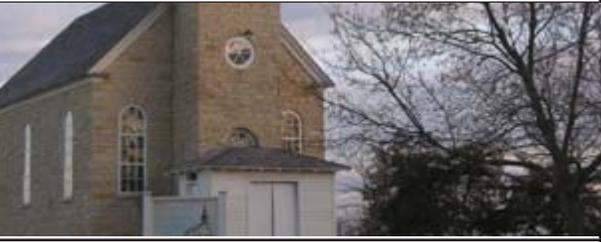
Window Frames	<ol style="list-style-type: none"> <li>1. Condition is good.</li> </ol>

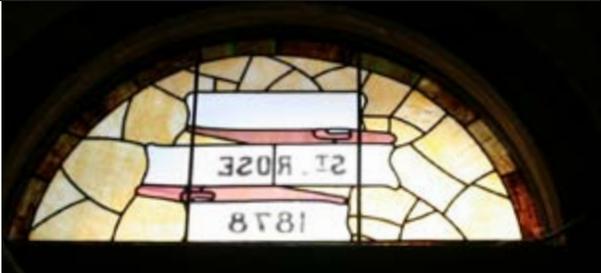
Half-Moon Stained Glass Windows	<ol style="list-style-type: none"> <li>1. This window is the only unprotected stained glass window in the building. There is a likelihood of wood rot and building envelope failure if the joint between the vestibule, building, and window is not maintained properly.</li> </ol>

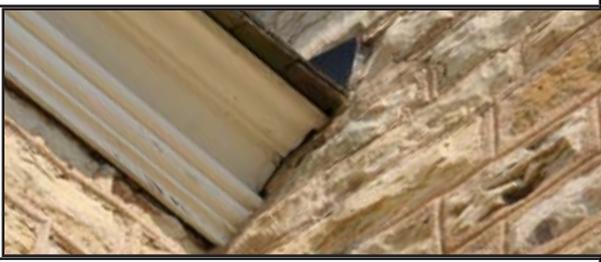
Cornice at Hipped Roof into Main Building	<ol style="list-style-type: none"> <li>1. At this location the joint has opened up and water infiltration has occurred. An excessive amount of sealant has been applied to mitigate infiltration.</li> </ol>

<ul style="list-style-type: none"> <li>Remove excess sealant and damaged flashing.</li> <li>Use backer rod and new flashing to cover joint completely. Then seal as required.</li> </ul>	<p style="text-align: center;">HIGH</p>	<p style="text-align: center;">TBD</p>
<ul style="list-style-type: none"> <li>Prepare cornices to be repainted.</li> <li>Repaint all cornices.</li> </ul>	<p style="text-align: center;">MODERATE</p>	<p style="text-align: center;">\$ 11,500.00</p>

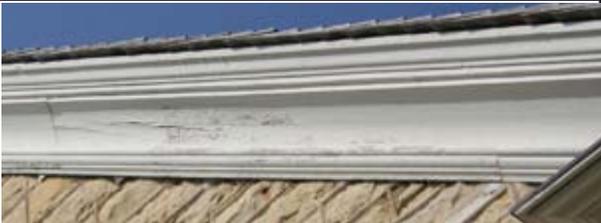
Cornice Painting	<ol style="list-style-type: none"> <li>1. Paint has begun to fail and bare wood is showing, which will eventually lead to water damage.</li> </ol>

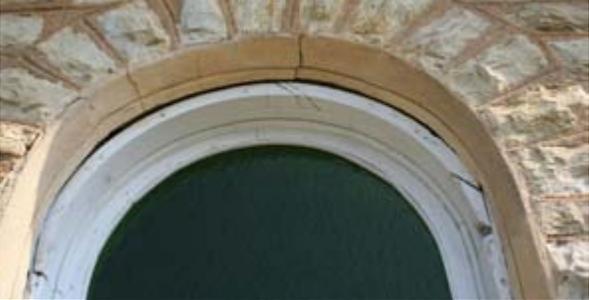
Item	Concern	Photo
Woodwork and Door to Sacristy	<ol style="list-style-type: none"> <li>1. Door and transom are pulling away from the stone.</li> <li>2. Threshold has severe rot and has lifted away from concrete steps.</li> <li>3. The door head and threshold are allowing water to infiltrate the building.</li> </ol>

Recommended Repairs	Level of Importance	Estimated Cost
<ul style="list-style-type: none"> <li>Replace transom glass, door frame and threshold while maintaining the historic integrity of the building.</li> </ul>	HIGH	\$ 4,500.00
<ul style="list-style-type: none"> <li>Repair spalling areas of stair.</li> <li>Replace wooden railing to provide a stable and freshly painted staircase.</li> </ul>	<p>CRITICAL (Railing)</p> <p>MODERATE (Repairs)</p>	\$ 2,500.00
<ul style="list-style-type: none"> <li>Replace door with new, white, weather tight door.</li> <li>Provide door security to reduce vandalism and break-ins.</li> <li>Install additional door at basement masonry wall.</li> </ul>	MODERATE	\$ 6,500.00
<ul style="list-style-type: none"> <li>Repair and replace brick and mortar at the top of the chimney.</li> <li>Provide pest protection such as a hooded cap or screening at the top of the chimney stack around the flue.</li> </ul>	MODERATE	\$ 3,500.00

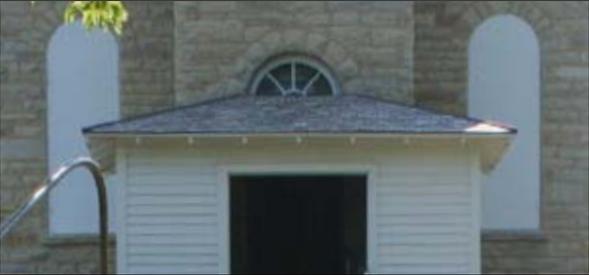
Wooden Vestibule Roof	<ol style="list-style-type: none"> <li>1. Roof line shows signs of sagging.</li> </ol>

<ul style="list-style-type: none"> <li>TBD if vestibule is retained.</li> </ul>	HIGH	TBD

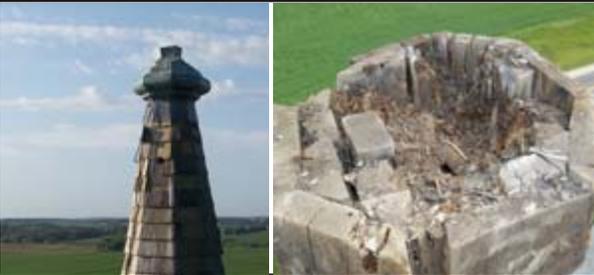
<p>Spire</p>	<ol style="list-style-type: none"> <li>1. Finial is in the church's possession, but not currently on the spire.</li> <li>2. Remaining structure has decayed and is damaged during.</li> </ol>

Recommended Repairs	Level of Importance	Estimated Cost
<p><b><i>Recommend removal of wooden vestibule and not replacing.</i></b></p> <ul style="list-style-type: none"> <li>• Prepare wooden vestibule to be repainted.</li> <li>• Repaint wood vestibule.</li> </ul>	HIGH	\$ 8,750.00
<p><b><i>Recommend removal of concrete stairs when/ if wooden vestibule is removed.</i></b></p> <ul style="list-style-type: none"> <li>• Replace concrete steps with ADA compliant ramp and steps.</li> <li>• Provide ADA complaint railing to match historically appropriate railings.</li> <li>• Provide door new locks to reduce vandalism and break-ins.</li> </ul>	HIGH	\$ 7,500.00
<ul style="list-style-type: none"> <li>• Repair spire structure for re-installment of finial.</li> <li>• Reinstall finial to its original condition.</li> </ul>	HIGH	\$ 6,200.00

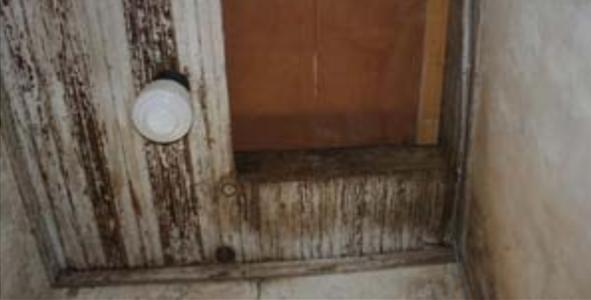
Item	Concern	Photo
Ceiling at Narthex	<ol style="list-style-type: none"> <li>1. The wood ceiling has water damage and has lost most of its paint.</li> <li>2. The trap door leading to the bell tower is not original.</li> </ol>

Recommended Repairs	Level of Importance	Estimated Cost
<ul style="list-style-type: none"> <li>Repair tongue and groove ceiling pieces where possible, replace when required.</li> <li>Prepare surfaces to be repainted. Repaint.</li> <li>Replace non-original trap door with historically appropriate door.</li> </ul>	HIGH	\$ 9,500.00
<ul style="list-style-type: none"> <li>Maintain a consistent temperature in the building to limit large temperature fluctuations. (On-going maintenance)</li> <li>Install a monitoring system capable of sending alerts to the Owner if the temperature drops below a given standard.</li> </ul>	LOW	\$ 250.00
<ul style="list-style-type: none"> <li>Investigate the condition of the lath and structure above the plaster ceilings.</li> <li>Stabilize the existing plaster ceiling and repair/replace the missing plaster.</li> <li>Paint.</li> </ul>	HIGH	\$ 6,000.00
<ul style="list-style-type: none"> <li>Repair and stabilize damaged wood if possible, replace if required.</li> <li>Patch/repair water and/or pest infestations, resolve source.</li> <li>Stain and varnish repaired wood to match similar existing historic woodwork.</li> </ul>	HIGH	\$ 4,500.00

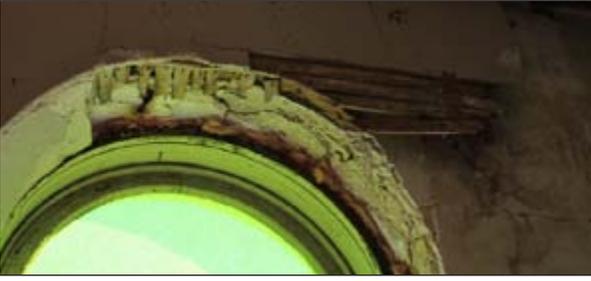
D. Severe damage in the sacristy, especially at the door. Structural stability of the plaster and lath is questionable

Plaster Walls at Sacristy	<ol style="list-style-type: none"> <li>1. Plaster has lost its structural stability, falling away from the lath and crumbling.</li> <li>2. Wood lath and structure behind plaster appears to be failing.</li> </ol>

<ul style="list-style-type: none"> <li>Investigate the condition of the lath and structure behind the plaster. Repair and required to stabilize.</li> <li>Remove loose or failing plaster, and replace in kind.</li> <li>Paint.</li> </ul>	HIGH	\$ 6,800.00

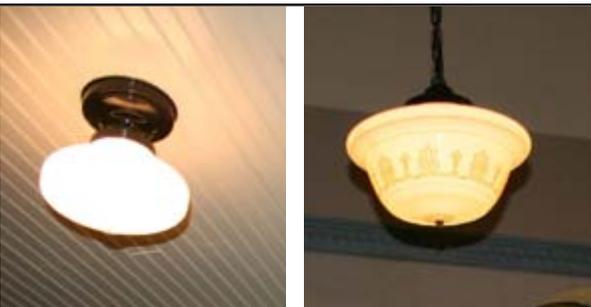
<p>Lighting</p>	<ol style="list-style-type: none"> <li>1. Lighting fixtures do not appear to be original.</li> <li>2. Lighting levels are low for the new uses of the building.</li> </ol>

Recommended Repairs	Level of Importance	Estimated Cost
<ul style="list-style-type: none"> <li>Monitor cracking on exterior walls for any widening of existing cracks or the occurrence of new cracks. (On-going Maintenance)</li> <li>Repair chips and deterioration.</li> <li>Paint.</li> </ul>	<p style="text-align: center;">MODERATE</p>	<p style="text-align: center;">\$ 1,500.00</p>
<ul style="list-style-type: none"> <li>Reposition lighting fixtures to help provide adequate lighting levels.</li> </ul>	<p style="text-align: center;">LOW</p>	<p style="text-align: center;">\$ 500.00</p>
<ul style="list-style-type: none"> <li>Investigate whether it is paint or gold leaf beneath the blue paint to determine the most appropriate way to remove the blue paint.</li> <li>Repair, refurbish and prepare wood surfaces for paint or leaf.</li> <li>Paint or gold leaf.</li> </ul>	<p style="text-align: center;">MODERATE</p>	<p style="text-align: center;">\$ 9,000.00 - 17,300.00</p>

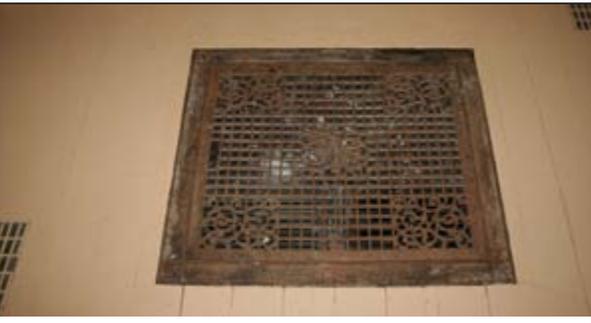
Another tripping hazard exists just outside the chancel in the front of the nave. (See Figure 38). Here a large historic heating grate is set in the floor. The openings in the grate may allow shoe heels to slip through the grate and become stuck. Although this is the most prominent grate, there is another one under the first row of pews.

<p>Floor at Nave</p>	<ol style="list-style-type: none"> <li>1. Furnace grates may be a tripping hazard.</li> <li>2. Furnace grates have begun to rust.</li> </ol>

<ul style="list-style-type: none"> <li>Remove the non-historic stairs at the Sanctuary and replace with the original configuration and material, including covering the opening in the floor at the back wall.</li> <li>Remove the adhesive tile and infill at the Chancel.</li> <li>Refurbish historic wood floors.</li> </ul>	<p style="text-align: center;">LOW</p>	<p style="text-align: center;">\$ 11,000.00</p>
<ul style="list-style-type: none"> <li>Remove rust and chipping paint from metal grates.</li> <li>Refinish with 'stove black' or other historically appropriate paint/sealant.</li> <li>Have a cover or boundary strip threshold made to fit over existing grate as temporary tripping protection during events.</li> </ul>	<p style="text-align: center;">MODERATE</p>	<p style="text-align: center;">\$ 1,500.00</p>

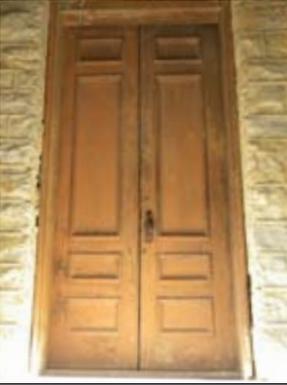
On the west side the doors leading into the narthex have not been refurbished. There is a functioning lock on the door, but a wood plank has been added for extra security. This set of doors is not in good repair, everything for the condition of the wood to the hardware needs to be addressed.

Item	Concern	Photo
Doors at Nave	<ol style="list-style-type: none"> <li>1. The exterior doors and frames on the west side of the building have very little protective finish left.</li> <li>2. Doors are no longer plumb, so the threshold and the doors suffer each time the doors are opened.</li> </ol>

Recommended Repairs	Level of Importance	Estimated Cost
<ul style="list-style-type: none"> <li>• Patch/repair doors and frames. Refinish to match existing interior doors and historic photos.</li> <li>• Refurbish hinges and other existing hardware. If necessary, provide secure attachment to frame.</li> </ul>	HIGH	\$ 6,500.00
<ul style="list-style-type: none"> <li>• At the stair landing window add either a railing that matches existing railing or a plexi-glass panel to protect window.</li> <li>• At the window in the stair add plexi-glass panel between stair and wall. Panel should run from edge of stair up a minimum of 42" to protect glass.</li> <li>• At the balcony add plexi-glass panel from balcony floor to top of window.</li> </ul>	MODERATE	\$ 3,500.00

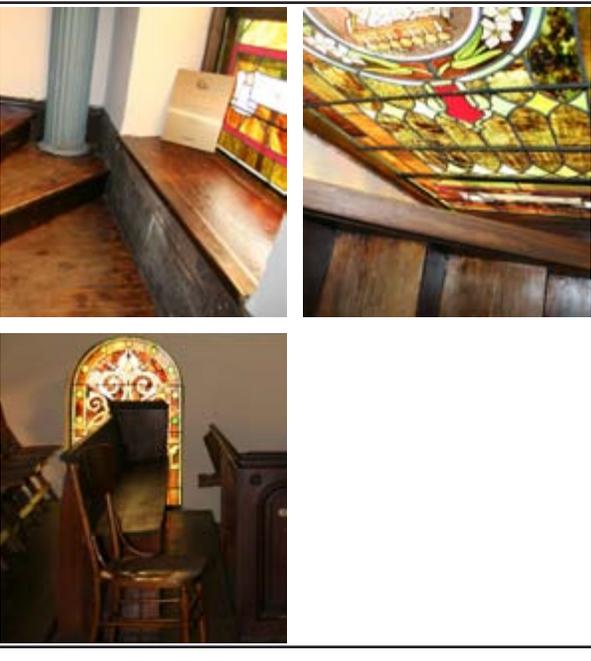
*Window W6* has a low railing running past it. However, this railing is not high enough to keep the stained glass safe or to keep a visitor from falling over the railing into the window.

*Windows W3 and W4* are located in the balcony, with the balcony running past each window. In these locations there is a gap between the balcony and the windows which a tripping and falling hazard.

Safety at Balcony Stairs and Balcony	<ol style="list-style-type: none"> <li>1. There is no railing between windows and stairs, which might allow someone to fall into the window(s).</li> <li>2. There is an open area between the balcony and the tops of two windows which might allow someone to fall through.</li> </ol>
